HYDROGEN CRACKING DURING SERVICE OF HIGH STRENGTH STEEL CANNON COMPONENTS

SEPTEMBER 1997

6. AUTHOR(S) J.H. Underwood, E. Troiano, G.N. Vigilante, A.A. Kapusta, and S. Tauscher					
7. PERFORMING ORGANIZATION NAME(S) AND ADDRESS(ES) U.S. Army ARDEC Benet Laboratories, AMSTA-AR-CCB-O Watervliet, NY 12189-4050				8. PERFORMING ORGANIZATION REPORT NUMBER ARCCB-TR-97021

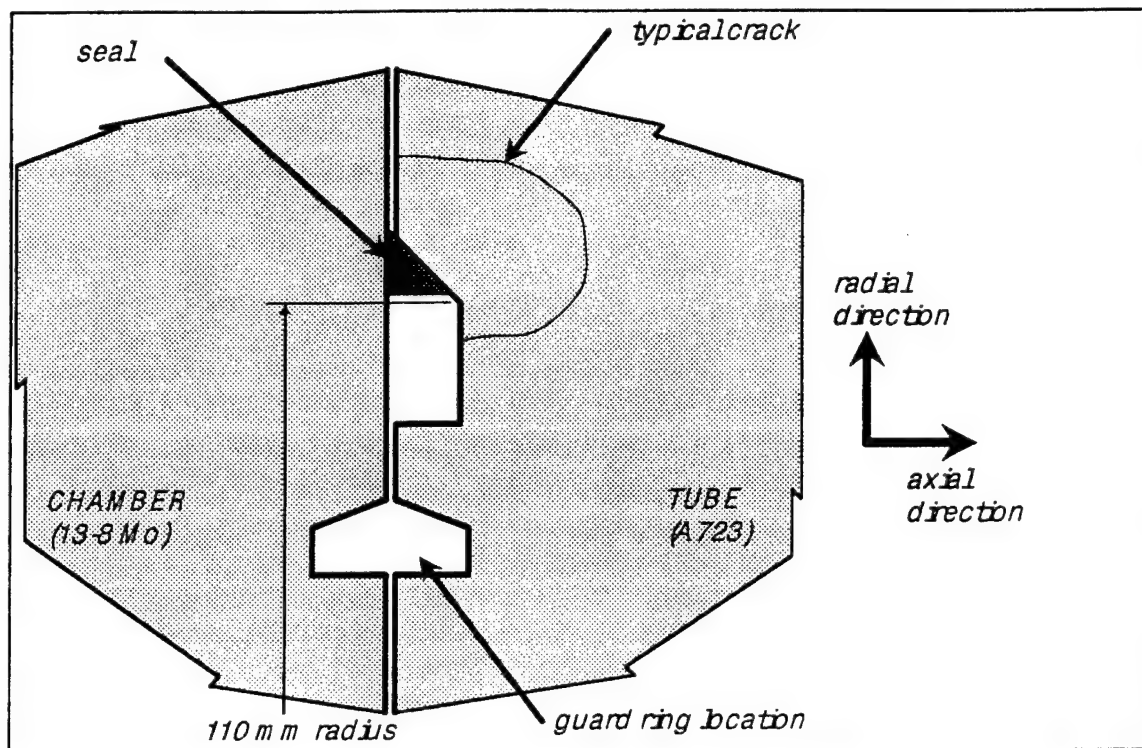
Cracking in the prototype cannon with the seal at location #1 was suspected due to a small pressure leak that was observed during the fifth firing cycle. The typical crack size and location sketched in Figure 2 show a 21-mm (surface length) crack that provided a pressure path around the seal and thus accounted for the observed leak. Two other cracks were observed at other angular positions of the seal, a 19-mm surface length crack at a position 185° away from the 21-mm crack, and a 6-mm surface length crack 111° away from the 21-mm crack. The angular positions are significant because the two largest cracks were within a few degrees of alignment with the two 180°-spaced vent holes in the guard ring, and the 6-mm crack was closely aligned with a plugged test hole in the guard ring contact surface of the tube. The presence of the plugged hole could have affected the contact surface and allowed passage of combustion products at this location. Thus, each of the three positions of cracking was closely aligned with angular positions of known (guard ring vent holes) or suspected (plugged hole) sources of propellant combustion products. This is strong evidence that the source of the environment that contributed to the cracking was the combustion products. Regarding initiation of the three cracks, each of the three cracks included the internal corner of the seal pocket adjacent to the seal. This corner is a likely origin of cracking. As shown in Figure 2, the larger two cracks extended farther from the corner toward the outer radius of the tube rather than toward the inner radius; this can be

explained in terms of the residual stresses in the cannon tube, discussed in the next section. The 6-mm crack was nearly centered on the internal seal pocket corner, thus indicating that this seal pocket corner was the origin of the cracks.

FIG. 2 - Sketch of Seal Location #1 and Cracking Observed

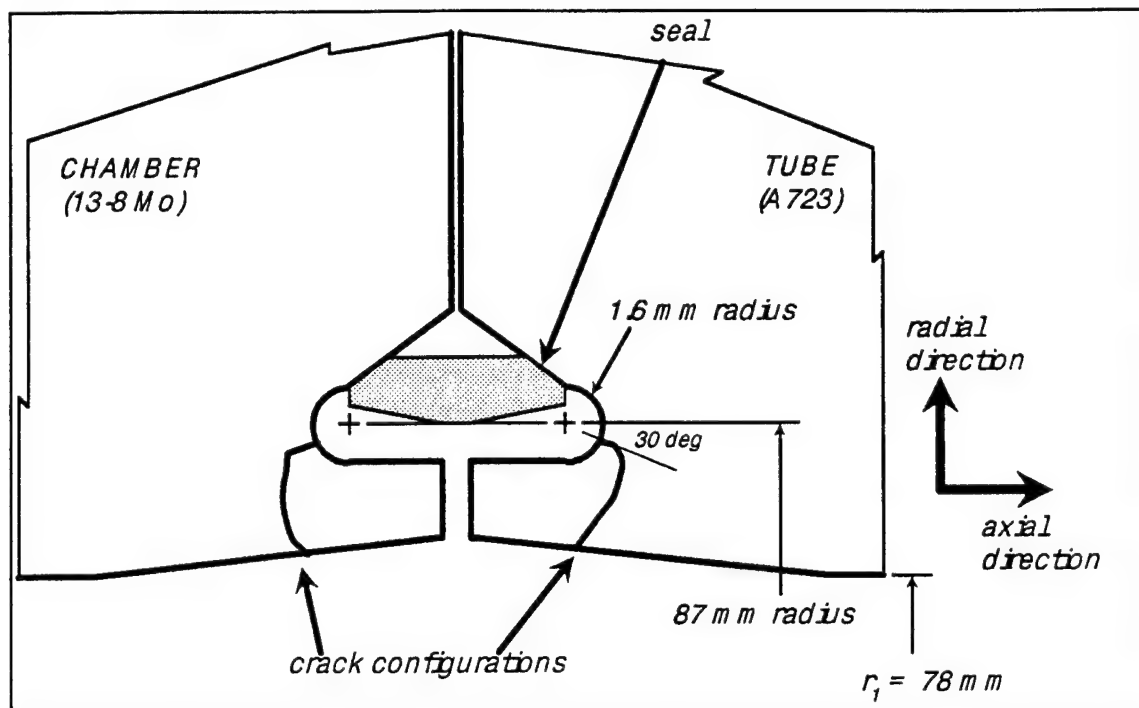
Seal location #2, shown in Figure 3, is at a position near the inner surface of the chamber and tube. A six-sided 17-4 PH stainless steel seal was used in a pocket configured to allow pressure on the seal while, as at location #1, preventing direct flow of propellant products onto the seal contact surfaces. The measured yield and ultimate strengths of the 17-4 PH steel used for the seal at location #2, 984 and 1053 MPa, respectively, were used in the finite element stress analysis discussed later. Strength and fracture properties measured from the 13-8 Mo stainless steel chamber and the ASTM A723 alloy steel tube are shown in Table 1. Fracture toughness was measured using ASTM Method E813 for J_{IC} , and the hydrogen cracking threshold measurements were performed as described in Reference 3.

Cracking in the prototype cannon with the seal at location #2 was found to be quite extensive when the cannon was disassembled after thirty firing cycles. Nearly identical crack configurations were observed in both the chamber and tube sections of the cannon, initiating from a location in the seal pocket about 30° from the axial direction in each section; see Figure 3. The cracks extended through to the inner radius surface and extended about 50 mm in the circumferential direction in each section. The similar location, size, and orientation of rapid cracking in components of different material is quite remarkable. The similar cracking suggests that a significant load was applied about equally at locations close to the seal pocket radius of both the chamber and tube, thereby overwhelming the expected differences in cracking resistance of the two materials. Referring again to Figure 3, the seal contact load that is applied to the seal surfaces of the chamber and tube meets this criterion of a significant local load being applied to both cannon sections. The question of whether or not seal contact loads can result in tension stresses in the seal pocket radius will be addressed later, in relation to the finite element results.

FIG. 3 - Sketch of Seal Location #2 and Cracking Observed

A reduced level of sustained tensile stress near pressure seals in these cannon components can be accomplished by design changes that reduce stress concentrations near the seal contact area. An increased seal pocket radius and a machining process with smaller inherent defect size would reduce the sustained stresses. A small further reduction in sustained stress can be accomplished by increasing the separation distance between the seal pocket area and areas of end load between cannon components.

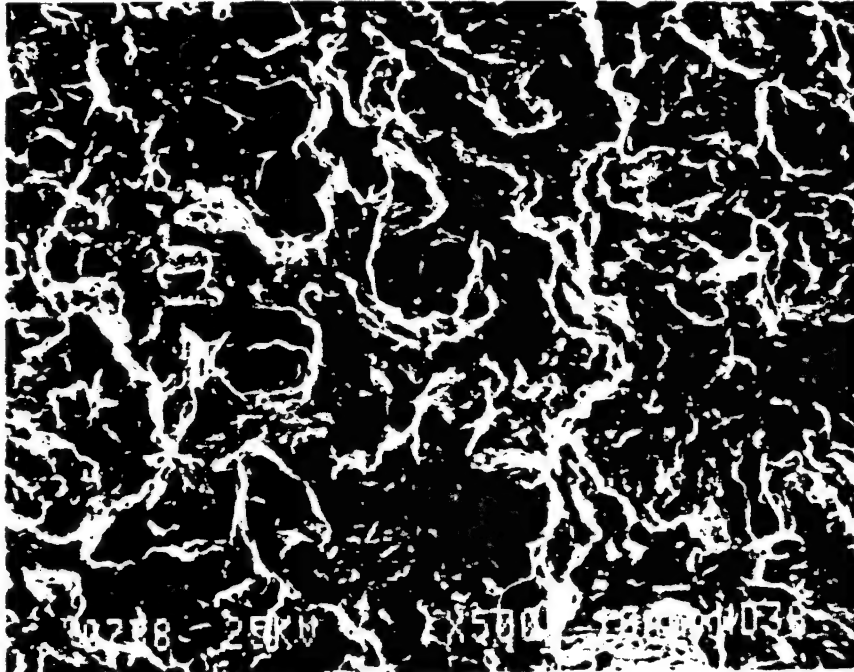
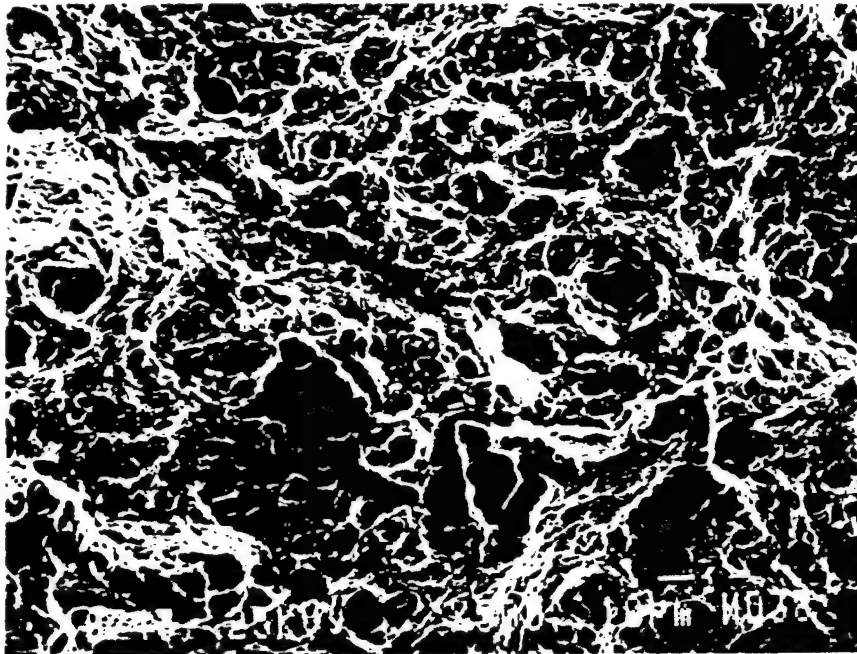
The fracture surfaces of the location #1 cracks were characterized using scanning electron microscopy. Figure 4[a] shows an area near the farthest extent of the crack, where the fracture surface was less affected by apparent corrosion products. Even though the surface was partially obscured, the intergranular nature of the fracture can be seen, indicating that environmental cracking had occurred. Figure 4[b] shows the microvoid coalescence fracture that occurred ahead of the area of firing-related cracking when the sample was broken apart.

FIG. 4 - Scanning Electron Micrographs of Location #1 Fracture Surfaces; [a] environmental cracking, 500x; [b] ductile fracture for comparison, 500x

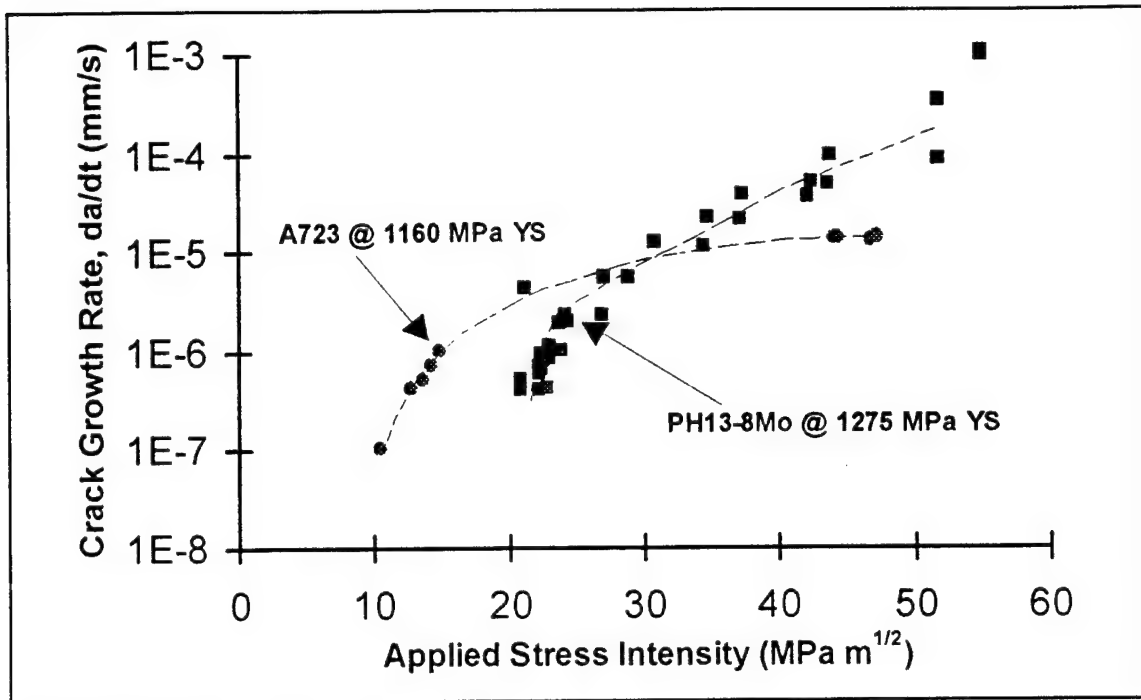
Laboratory hydrogen cracking tests (ref 3) have been performed in response to the earlier environmental cracking incident (ref 1) and to the cracking under discussion here. Results from the prior work with direct application to the discussions here are shown in Figure 5. Bolt-loaded compact specimens were machined from the tube and chamber sections described here and tested in an electrolytic cell containing a 3.5 percent aqueous NaCl solution containing As_2O_3 poison and using a current density of 40 ma/cm². Additional information on the tests is in Reference 3. Crack growth rate from a five-point moving average varies over four orders of magnitude for the two materials. A larger increase in da/dt with increasing applied K was noted for the 13-8 Mo steel, compared with A723. The two materials had about the same da/dt of 10⁻⁵ mm/s at an applied K of 30 MPa m^{1/2}. Since there was a similar amount of observed cracking at location #2 for the chamber and tube cannon sections, it will be interesting to see if this value of 30 MPa m^{1/2} is consistent with the calculation of applied K based on finite element results, described later.

The value of applied K determined above, 34.7 MPa $m^{1/2}$, compared with the growth data in Figure 5, can account for the cracking observed at location #2 in both the A723 steel tube and the 13-8 Mo steel chamber. Of course, the value of applied K depends on the assumption of a 0.1-mm deep, 0.02-mm radius defect, but these values are believed to be representative of typical manufacturing methods. Recent work (ref 8) in fatigue initiation with cannon components supports this belief.

FIG. 5 - Hydrogen Cracking for Two Steels; 3000 hours in Electrolytic Cell

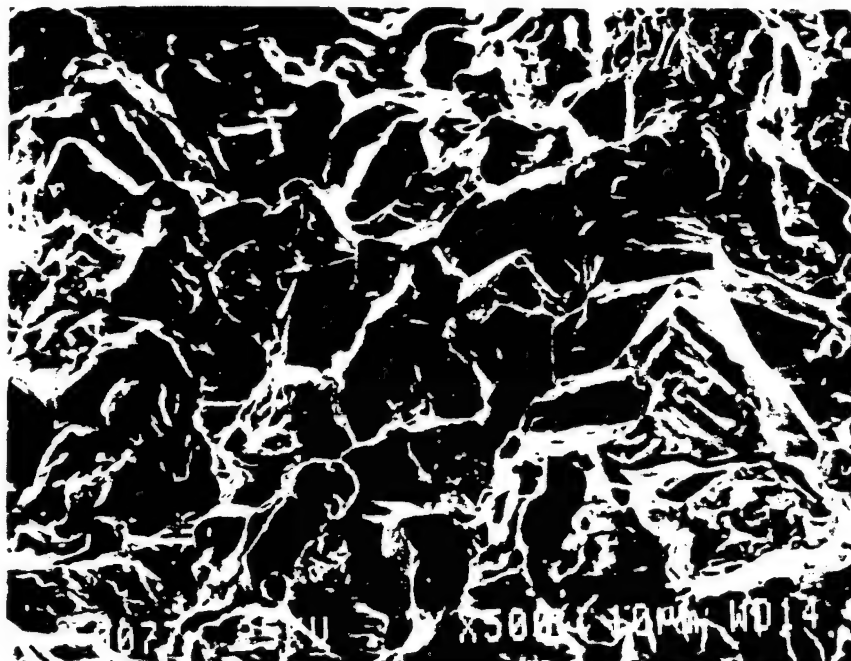
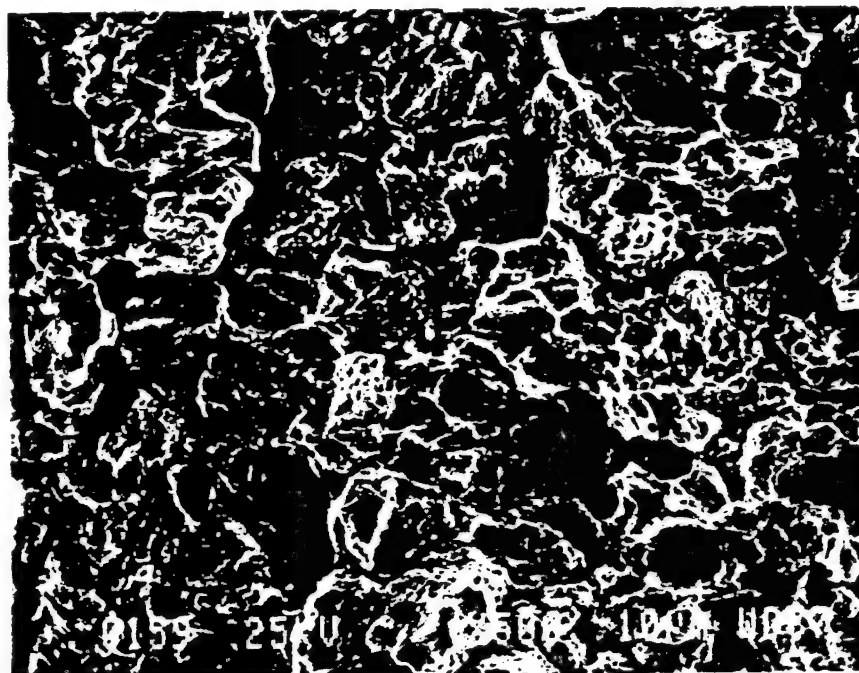
Scanning electron fractography was performed on samples from the hydrogen cracking tests described in Figure 5. Results are shown for the 13-8 Mo and A723 steels in the sustained cracking area affected by environment, Figures 6[a] and 6[b], respectively. The 13-8 Mo fracture surface was quite classic intergranular fracture, typical of hydrogen cracking. The A723 steel also shows clear evidence of intergranular cracking, as well as secondary cracking, both obscured to some degree by corrosion products. More effects of corrosion are expected with the A723 steel

because of its much lower Cr and Ni content. Note also that there is a general similarity between Figure 6[b], from the A723 laboratory tests, and Figure 4[a], from the location #1 failure of the A723 tube section as a result of firing.

FIG. 6 - Scanning Electron Fractographs from Electrolytic Cell Tests;
[a] 13-8 Mo, 500x, 3000 hours exposure; [b] A723, 500x, 3000 hours exposure

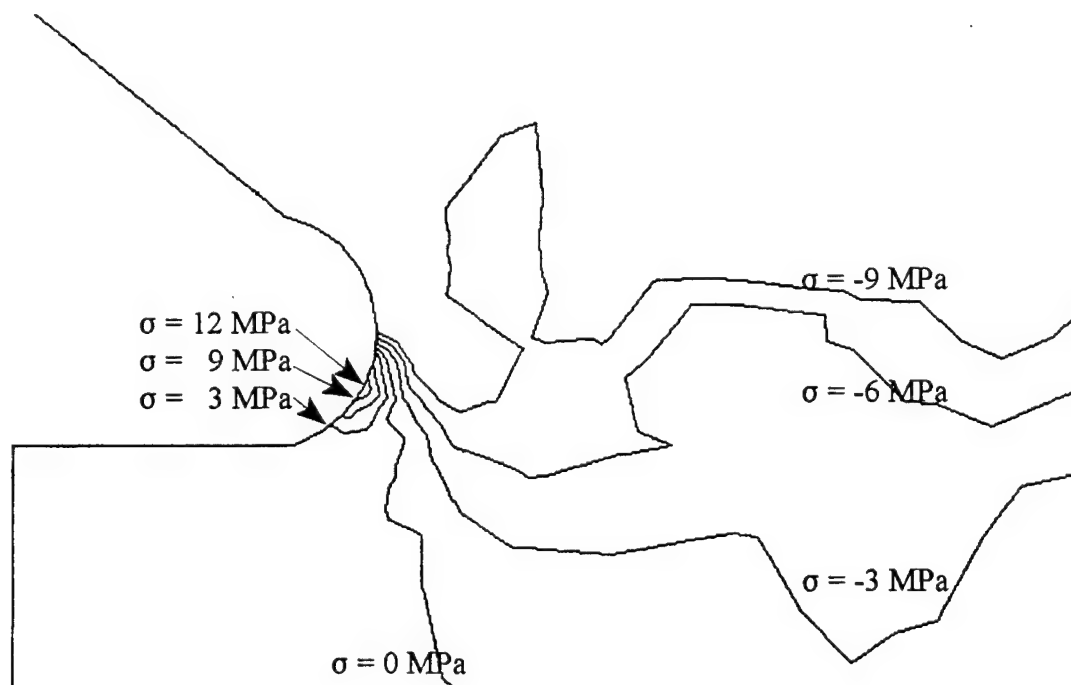
Results of the finite element analysis are given in Figures 8 and 9, which show contour plots of the radial direction stresses in the area of the seal pocket. Recall from Figure 3 that the location #2 cracking in both components started within 30° of normal to the radial direction. Figure 8 shows the radial stress distribution resulting from the 156 MPa end load. The maximum radial tensile stress in the seal pocket radius is 12 MPa at an angle of 29° from the radial direction, compared with 30° from the radial direction for the observed cracks in Figure 3. Note that most stresses in the area of the seal pocket are compressive and that the $\sigma = 0$ contour approximates the direction of the observed cracks shown in Figure 3. Figure 9 shows the radial stress distribution resulting from the 3023 MPa seal contact load. The maximum radial tensile stress in the seal pocket radius is 233 MPa at an angle of 14° from the radial direction. As with Figure 8, most stresses in the area of the seal pocket are compressive and the $\sigma = 0$ contour approximates the direction of the observed cracks. It is clear from these results that stresses from both end loads and from seal contact loads can account for the initiation location and the growth directions of the observed cracking, and that the seal contact loads have the more significant quantitative effect on cracking. Next, these results will be used to calculate the approximate value of applied stress intensity factor, for comparison with the measured crack growth rate versus applied K data presented earlier.

FIG. 8 - Radial Stresses for Location #2 with Average End Load of 156 MPa

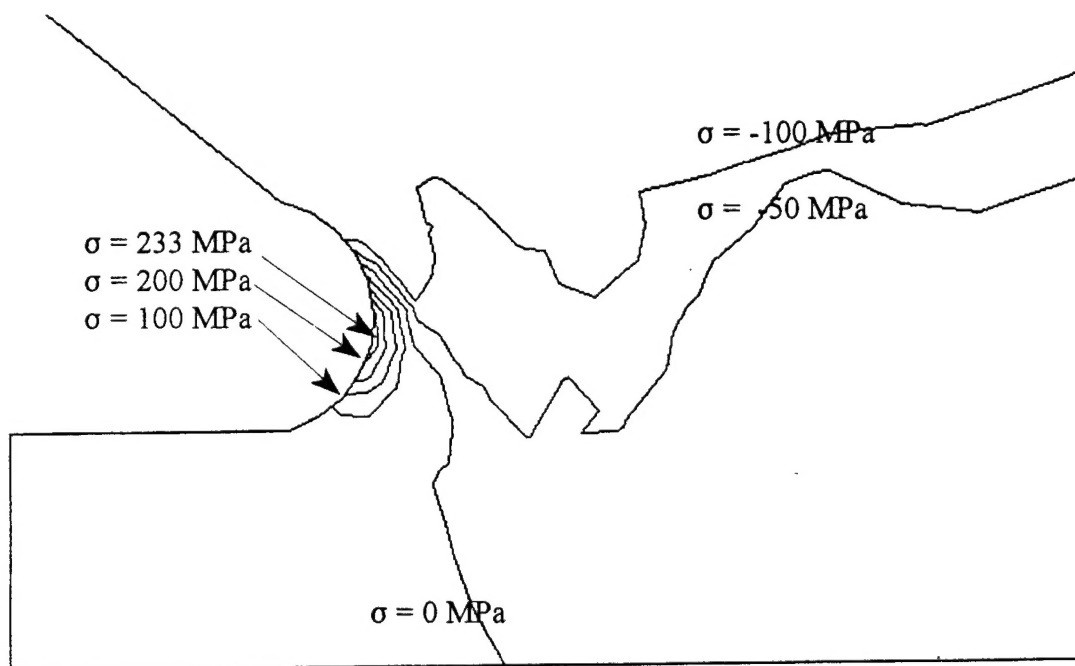
FIG. 9 - Radial Stresses for Location #2 with Average Seal Load of 3023 MPa
